dsPIC30F1010/202X

dsPIC30F1010/202X Family Silicon Errata and Data Sheet Clarification

The dsPIC30F1010/202X family devices that you have received conform functionally to the current Device Data Sheet (DS70178C), except for the anomalies described in this document.

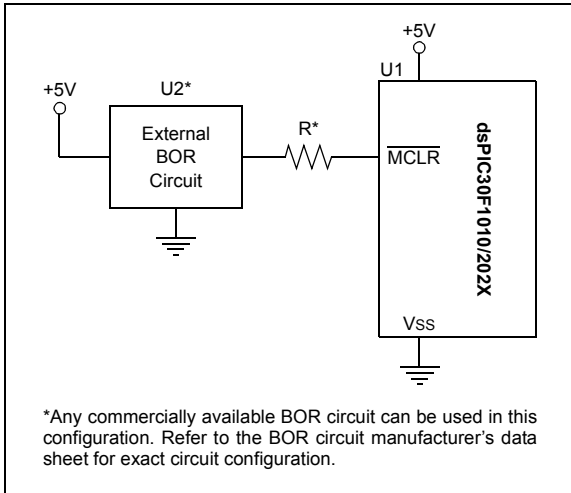
FIGURE 1:

It is recommended that an external Brown-out Reset (BOR) circuit be used to hold the device in Reset, during a brown-out event, to overcome this problem. The external BOR circuit will use the MCLR pin to hold the device in Reset. The following work around, in combination with the external BOR circuit, will ensure that the device is cleanly reset after a brown-out event occurs.

The dsPIC DSC SMPS device must be powered up with the PLL disabled, the Fail-Safe Clock Monitor (FSCM) enabled and clock switching enabled. The PLL should be enabled in software via a clock switch after the device is reset (refer to **Section 29. "Oscillator"** (DS70268) in the "*dsPIC30F Family Reference Manual*" for details on clock switching). This ensures that the MCLR pin is functional and that the device can be reset by an external BOR circuit (see [Figure 1](#)).
