MCF5282 Chip Errata

Silicon Revision: All

Document Number: MCF5282DE
Rev. 8, 02/2015

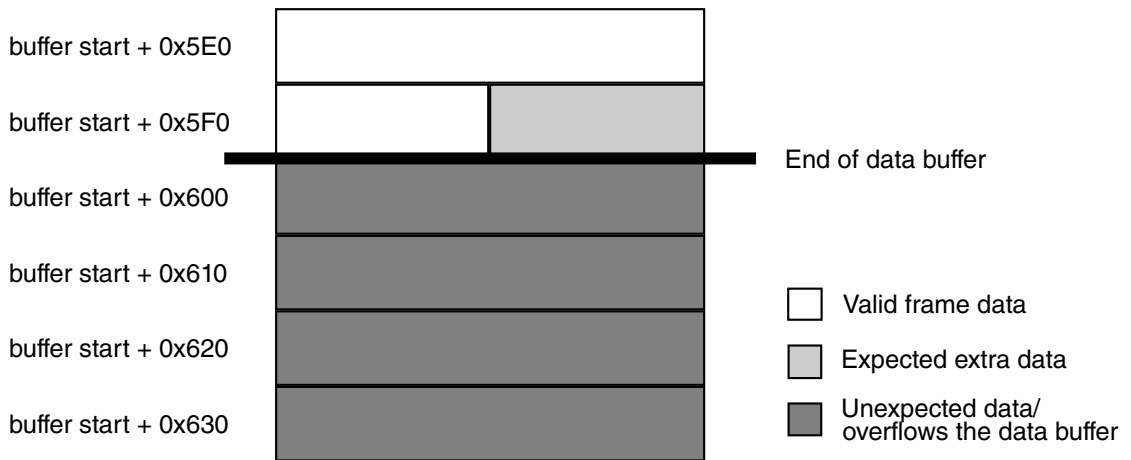
Figure 1. Buffer Overrun Example

SECF009: FEC Receive Buffer Overrun in 10BaseT Mode

Description: When the FEC is connected to a 10BaseT network, if length of the data stored in a descriptor is not evenly divisible by 16 (not line-aligned), the FEC writes extra lines at the end of the buffer. The entire line that contains the last valid data is written and at least one extra line, but

up to four lines after the end of the valid data can also be written. In most cases, this is not a problem because the extra lines of data continue falling within the limits of the buffer. However, if the valid data ends near the end of the buffer, the extra lines written by the FEC might be outside of the data buffer. This leads to corruption of the next buffer, descriptor, data, or code stored in the adjacent memory.

For example, as shown in the figure below, if the max buffer size is programmed to 0x600 and a frame that is 0x5F8 bytes long is received, a line is written starting at buffer start + 0x5F0. The first half of the line at buffer start + 0x5F0 is valid frame data that should be processed by the FEC driver; the second half of the line is additional data that is written because the FEC only writes complete lines. This data should be ignored by the FEC driver. So far, this is correct FEC behavior as originally specified. However, the FEC repeats the last line of valid data a number of times. The line at buffer start + 0x600 is written, and as many as three additional lines beyond the end of the data buffer could be written.

Workaround: Only use 100BaseT.

Workaround: Allocate extra lines for the receive data buffers. The actual allocated memory for each buffer should be equal to the receive buffer size programmed in the FEC's EMRBR register plus four lines (16 byte-sized lines).

Workaround: Program the data buffer size one line larger than the max packet size (data buffer size = EMRBR + 0x40).
