Bulletin No. G310SBK-X Drawing No. LP0794 Effective: 09/09

### **G310S REPLACEMENT BACKLIGHT ASSEMBLIES**

### **DETERMINING BACKLIGHT REPLACEMENT KIT**

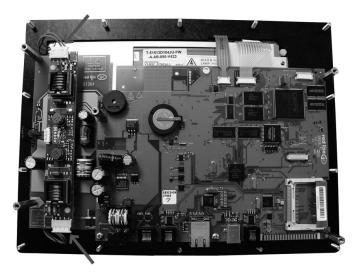
# OPTREX CCFL BACKLIGHT (Two Backlights, Three Wires Each)

For customers with an original Optrex display that uses two CCFL backlights, part number G3BR10S1 is used to convert the existing display to use the new LED backlight assemblies. This kit contains two backlight assemblies and a board that drives these new LED assemblies.

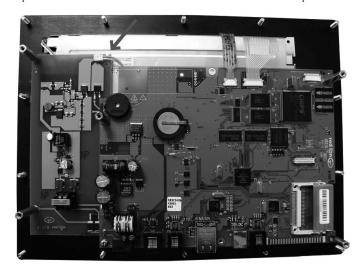
# NEC LED BACKLIGHT (One Backlight)

For customers with the newer NEC display, this backlight is not field replaceable. This unit must be returned to Red Lion Controls for repair.

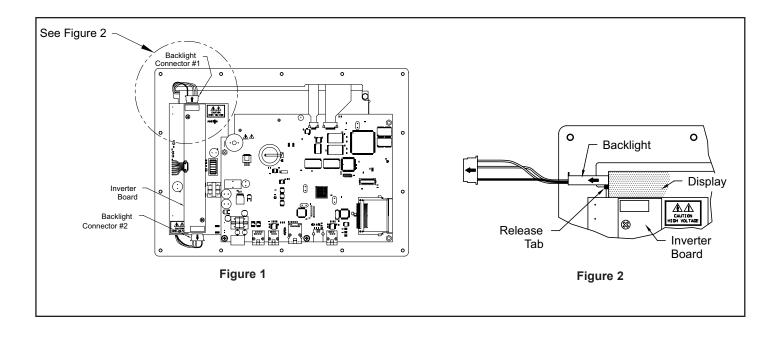
- 1. Remove the power and PLC Communications connectors from the unit.
- 2. Remove the five screws from the rear cover.
- To replace the inverter board with the LED driver board, carefully remove heat shrink tubing (if present) from the backlight connectors on the inverter board (refer to Figure 1).
- Remove the backlight connectors from their connector housings on the inverter board.
- 5. Disconnect the 8-position cable from the inverter.
- 6. Carefully remove the two nylon screws holding the inverter in place.
- 7. Replace the inverter with the new LED driver board.
- 8. Reinstall the 8-position cable into the new LED driver board.

- 10. To replace the backlight assemblies, depress the backlight release tab and carefully remove the backlight as indicated in Figure 2. Repeat for the other backlight.

- 4. To replace the backlight assemblies, depress the backlight release tab and carefully remove the backlight as indicated in Figure 2. Repeat for the other backlight.
