3M

3838 PST/Gel Buried Service Wire Splice Kit

Technical Report

Issue 2, 80-6108-4826-1

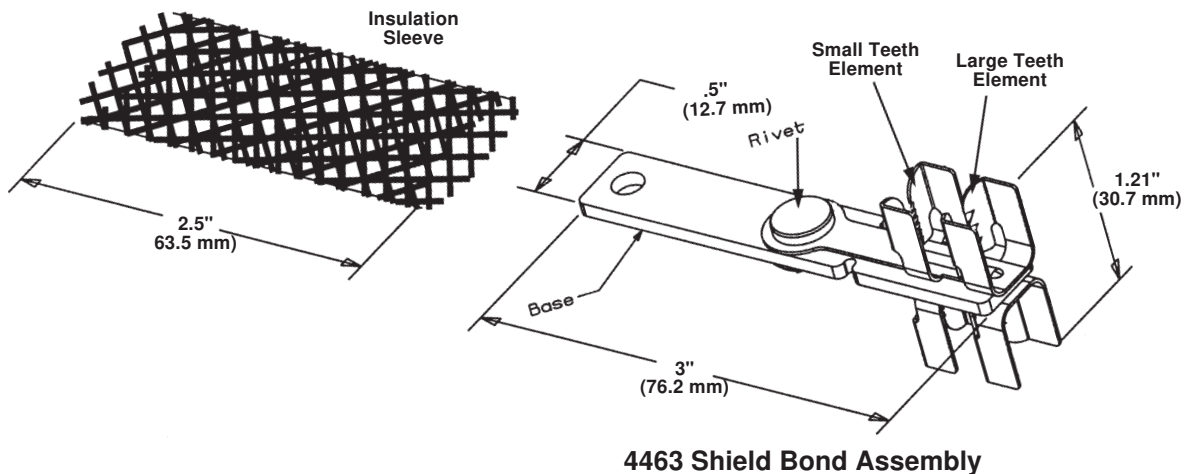
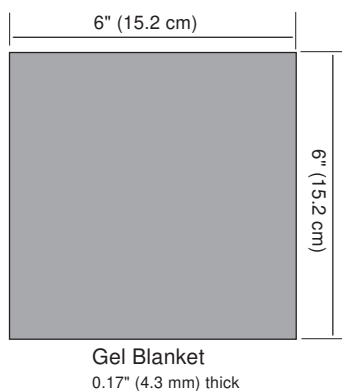
3M™ 3838 PST/Gel Buried Service Wire Splice Kit Components

The 3M™ 3838 PST/Gel BSW splice kit will accommodate up to six pair buried service wire with a maximum diameter of 0.45 in. (11.4 mm) in either an in-line or butt splice configuration. Maximum diameter of a cable up to 0.65 in. (16.5 mm) can be used with the kit if a 3M™ Scotchlok™ 4460D shield bond connector is used. A 3M™ Scotchlok™ 4463 Service Wire Shield Connector and strain relief clamp are included for easy shield bonding, splice protection and strain relief to the buried service wires. The parts included in each kit and their dimensions are illustrated in the diagrams shown on the next page.

The 3M™ 3838 PST/Gel Buried Service Wire Splice (BSW) Kit is designed to be a protection device to guard splices on filled or unfilled PIC buried service wires. No encapsulant is needed. The PST/Gel is designed to maintain the integrity of the closure body against any water or moisture entering the closure and maintain the high insulation resistance between all wire pairs. The closure is resistant to saltwater (3.5% sodium chloride), acid (3% sulfuric acid), base (0.2N sodium hydroxide), and cable filling compounds. It is compatible with encapsulant possibly found in the field condition.
